Smoke and Dye Testing Summary

High Level Sewershed

Test ID	Test Type	Date Inspected	Company / Super.	Blower MH	Ground Condition	Notification Made?	Total Length
S1028-116	Smoke	10/16/2008	ADS/TM	S07QQ_021MH	Dry	Yes	1,813.13

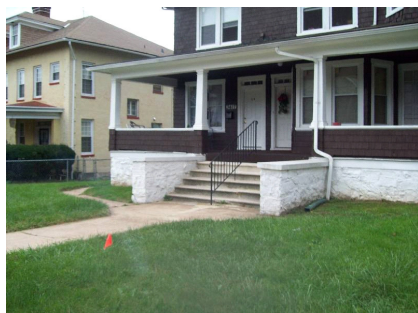
Picture \S1028-116-OB01-P01.jpg

Source Cleanout

Location Yard - front

Comments Smoke from cleanout in front yard. 3417 Alto Rd.

Comments Front of house, 3417 Alto Rd.

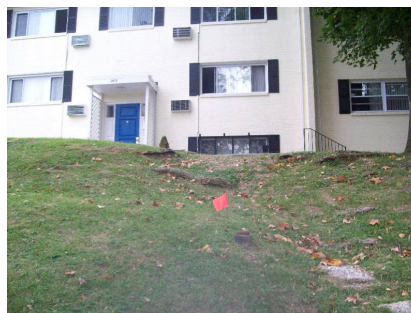
Picture \S1028-116-OB02-P01.jpg

Source Cleanout

Location Yard - front

Comments Smoke from cleanout in front yard. 2605 Garrison Blvd.

Comments Front of apartments, 2605 Garrison Blvd.

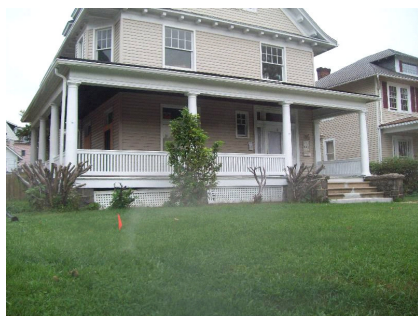
Picture \S1028-116-OB03-P01.jpg

Source Cleanout

Location Yard - front

Comments Smoke from cleanout in front yard. 2709 Garrison Blvd.

Comments Front of house, 2709 Garrison Blvd.

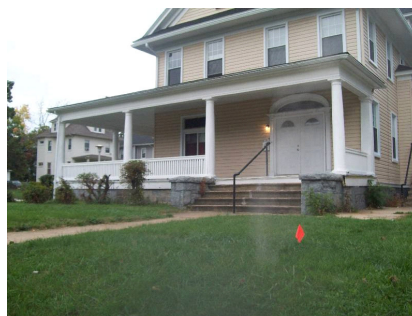
Picture \S1028-116-OB04-P01.jpg

Source Cleanout

Location Yard - front

Comments Smoke from cleanout in front yard. 2711 Garrison Blvd.

Comments Front of house, 2711 Garrison Blvd.
